# Massachusetts Department of Environmental Protection Bureau of Resource Protection – Watershed Permitting Program Sanitary Sewer Overflow (SSO)/Bypass Notification Form

3.	SSO Discharge fro	om:	Manhole	· · · · · · · · · · · · · · · · · · ·			
		Specify:	Sewage				
4.	SSO Discharge to:	SSO Discharge to: Ground Surface			-		
	Specify: Sewage flowed to 2 nearby storm drains and reached the Town's MS4 [Pictures attached]					hed]	
	th		st Address: 194 - 206 Atlantic Ave. LAT/LONG: +42.266524/-70.841760 Discharge bubbled up from manhole onto ad surface and then flowed to edges of the road toward two storm drain catch basins. Catch basins then flowed to e				
	(Description of discharge site or closest address)

## Sanitary Sewer Overflow (SSO)/Bypass

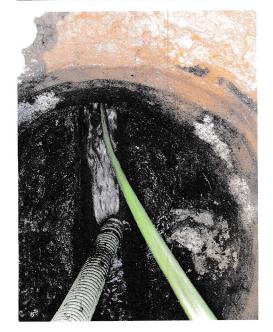
12-19-16 194/205 Atlantic AVE AREA PHOTOS

6.	Cause of SSO Eve	ent:	Sewer System Blockage				
		Specify:					
7.	Corrective Actions	:	8-inch sewer line blockage due to grease. Rosano-Davis Pumping contacted to pump out the manholes [5] and stop the SSO. and jet out affected manholes and sewer lines [approximately 700 ft]. Verify flowing well.				
	Impact Area cleaned and/or disinfected: Yes Corrective Actions Completed: Yes						
	Details: See above under corrective actions. Standing water in edges of road vacuumed up. Lime applied to all impacted areas.
